An Archaeological Assessment of
THE POWER'S HOUSE (Site 9FU561)

Morgan Falls Park, Sandy Springs,

Fulton County, Georgia

August 18, 2009 • Redacted Report
New South Associates Technical Report 1775

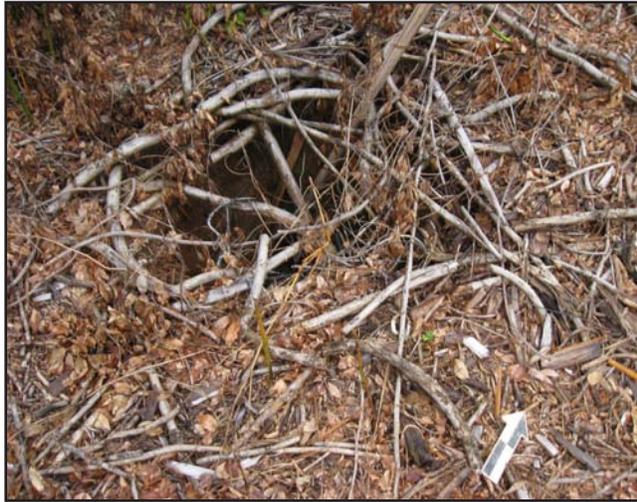
A. Well

Other features on the site with the potential to contain artifacts associated with the Powers occupation would be the well and privy. The well is an open, earthen shaft, with an associated electrical junction box, suggesting that it may have been used into the twentieth century. It appears unlikely to contain significant refuse deposits. The location of the house privy was not identified, although as noted above, the presence of a pathway may indicate the privy's location on a leveled landform behind the house.

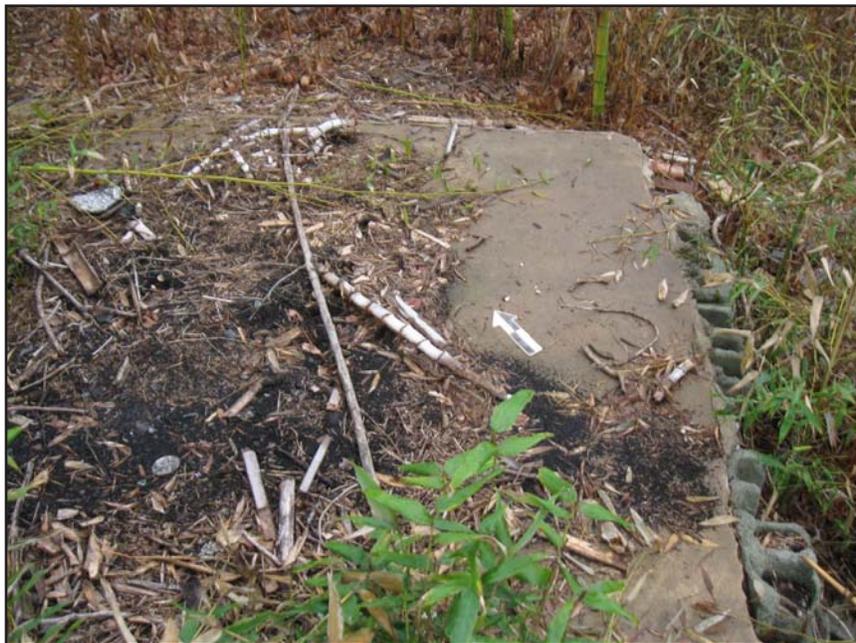
C. Concrete Pad

concrete pad. Automotive-related refuse was observed around the concrete pad and adjacent to the leveled ground suggesting these areas were used for parking during the twentieth century. An additional twentieth-century feature consisted of formed concrete stairs extending from the ridgeline down toward the eastern shoreline line of Bull Sluice Lake, terminating at a level area surrounded in stone. The stairs began 15 meters (50 ft.) south of the chimney fall, extending toward the eastern shoreline for 12 meters (40 ft.).

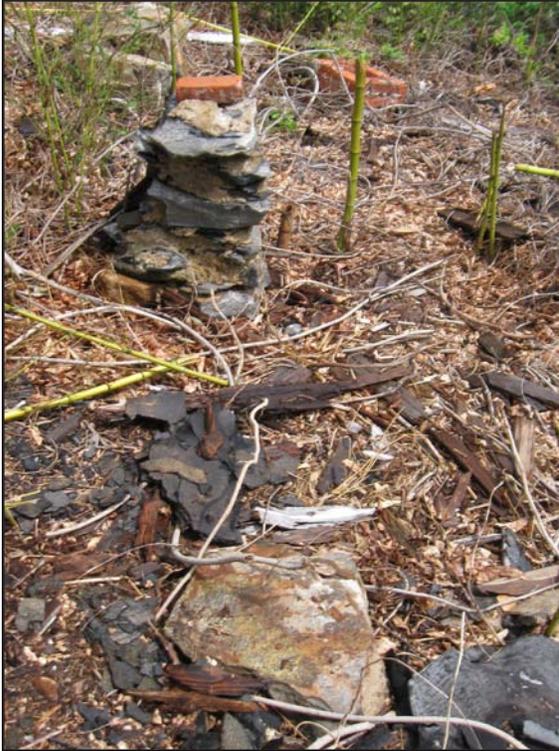
The structural remains of the house contained several intact architectural features. Several foundation piers of various materials were observed on the periphery of the concentration of building debris. A line of concrete blocks was noted along the south edge of the house. The blocks likely supported a porch and were spaced approximately 2.5 meters apart (8 ft.). Additionally, a large stone was situated in the center of the south edge of the building debris and likely served as the entrance or stoop to the porch. Other foundation features consisted of stone piers observed on the northeastern limits the dense building debris. These piers were comprised of rough-hewn gneiss stones bonded in modern Portland-like cement (Figure 4A). The stones of these piers were not weathered to the degree of the stones found in the chimney and chimney fall. This suggests that they were introduced later. These piers were clustered in an "L" shape and roughly measured 45 centimeters square (18 inches) in plan. Other stone piers were noted along the northern limits of the building debris field but were obscured by dense midden. The northern edge of the building also featured a collection of twentieth-century water and sewer utilities. These utilities were situated toward the center of the northern edge of the structure. The northwestern quadrant of the building debris contained a formed concrete footing or foundation whose extent is obscured by the overburden (Figure 4).

A. Piers Along the Northeast Corner,
View North

Exposure of the house piers would allow for a more detailed analysis of the site's architecture and could be accomplished by removing the collapsed building debris from the site, possibly with some limited excavation. Extant piers suggest that unweathered stones bonded in modern concrete were used for twentieth-century additions while weathered schist was used in the original construction. Hence, exposing and identifying all piers and the stones used should allow the house plans and additions to be better defined.

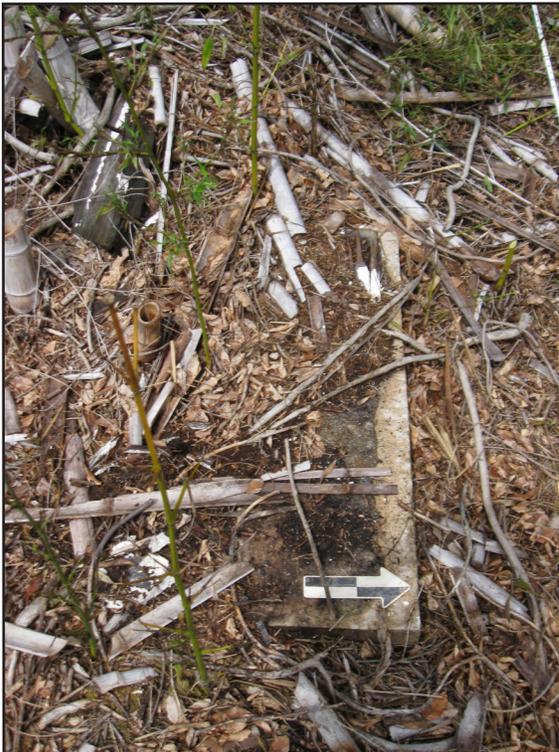
C. Formed Concrete Feature in the
Northwest Corner

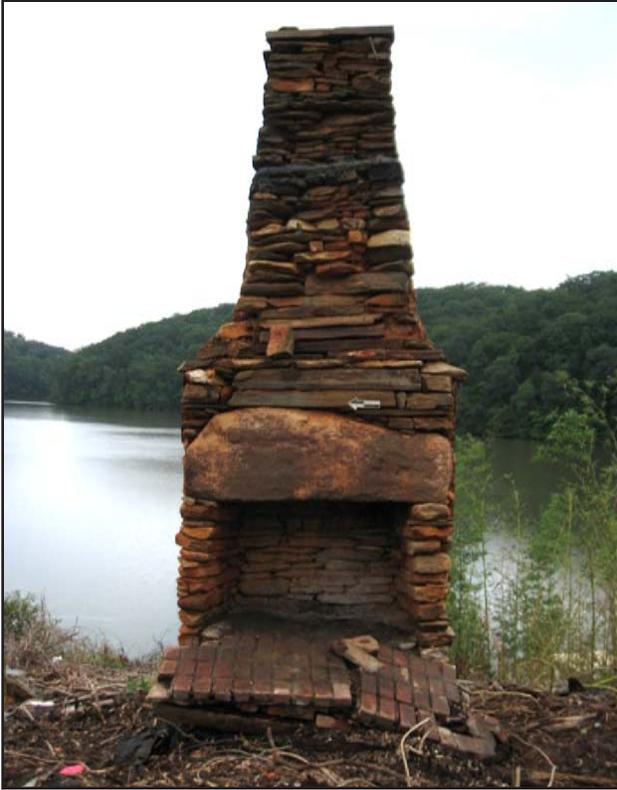
The standing chimney and chimney fall provided the most dramatic intact features associated with the house site (Figure 5). Both chimneys were comprised of uncut, natural faced schist and gneiss stone of various size collected from local sources and organized into irregular courses. The stones of each chimney were bonded in a coarse clay mortar containing varying degrees lime. The uncut, irregularly coursed stones and the coarse clay mortar suggested these masonry features are the earliest architectural components of the house. The chimney on the eastern edge of the debris field remained upright while the second chimney located in the southwestern quadrant of the house ruin had toppled, leaving a portion of the base and firebox intact.

Both chimneys exhibited impact from twentieth-century occupation of the house. Among the scatter of stones comprising the southern chimney fall, a cap of modern brick was noted and was likely added as a twentieth-century repair or extension. Likewise, the standing chimney featured a line of modern concrete and industrial sealant running vertically along its south and north profile representing the points where walls joined with the rock face. Additionally, modern roofing mastic is evident where the roof attached to the chimney on the upper half of its western face. The horizontal orientation of the line of mastic suggests a sloping roofline rather than a gabled end to eastern roof of the house.

The standing chimney measured approximately 1.8 meters (6 ft.) north to south and one meter (3.3 ft.) east to west in plan. It was approximately five meters (16.5 ft.) high, measured along the eastern face from the ground surface to the capstones. The entire masonry structure featured a slight cant toward the east, a likely result of settling after construction. The settling of the chimney occurred prior to the twentieth century, which is evident in the plumb nature of the line of modern concrete and sealant running its profile. The stonework was formed of a matrix of rocks of various sizes and shapes organized into rough courses. Larger stones were shimmed with smaller ones and bonded with a mortar composed primarily of local red clay. A single large slab of stone set on its narrow side served as the mantle above the firebox that measured 1.38 meters (4.5 ft.) wide, 0.6 meters (2 ft.) deep, and 0.8 meters (2.6 ft.) high (Figure 6). The chimney was documented with photographs and measured drawings, and a sample of mortar was taken for comparative analysis.

A. The Standing Chimney, View East

As the most prominent features surviving on the site, the two chimneys should be stabilized and preserved. The south chimney, which was apparently altered by replacement of the top of its shaft with brick, is already mostly collapsed. This chimney would best be left as ruins. The remains should be stabilized by (1) not removing any more stone, and (2) resecuring loose stones that remain in place and (3) reinstating the lintel over the fire box if feasible. The eastern chimney remains complete and every effort should be made to preserve it in situ. The ground has eroded considerably on what was the eastern end of the house, allowing the chimney to slowly shift out of plumb. Without stabilization, it will eventually collapse. As soon as possible, the chimney should be braced on the east side with non-invasive supports, perhaps in a manner similar to what is being done to stabilize the buildings at Hyde Farm. (Note: There are similar conditions at the Stafford slave quarters on Cumberland Island and the National Park Service has installed bracing to prevent collapse of those chimneys. The Service is also exploring the idea of "ghosting" the outline of the lost houses, similar to what was done for the home of Benjamin Franklin in Philadelphia, and using that as a means to stabilize the chimneys.) The chimneys should be repointed, replicating as far as possible the original materials and craftsmanship. Deconstruction and reconstruction of the chimney should be avoided as these procedures would eliminate most evidence of the craftsmanship even if the stones could be re-laid in their original positions. It might be possible to correct some or all of the tilt of the chimney after the stonework has been stabilized and repointed.

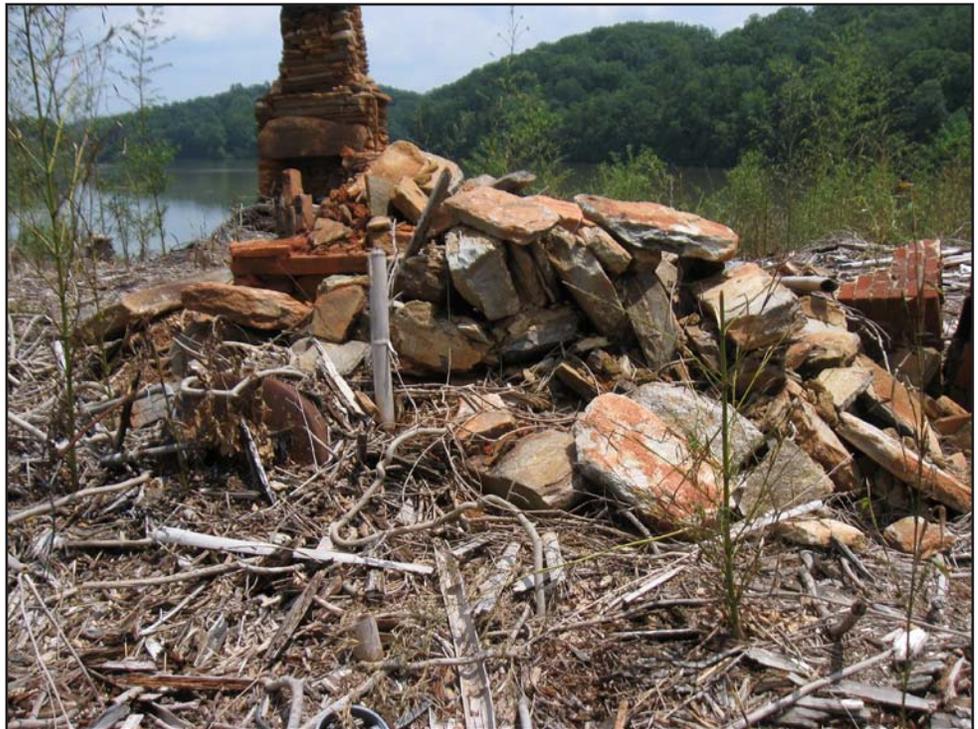
The firebox of the chimney fall to the south was the only intact element of the second chimney. A large mantle stone similar to that of the standing chimney was noted in the rubble north of the remains of the firebox while the majority of the chimney stone was located to the south and west. The modern brick cap rested directly south of the firebox remains. The rubble of the fall obscured the former form of the south chimney, and it was initially proposed that the chimney featured a double firebox, with an opening to the south and north. However, only the one large mantle stone

B. The Chimney Fall, View East

was identified in the rubble, to the north. Aside from the modern brick cap, the chimney fall contained stones similar to those observed in the standing chimney. The chimney was documented with photographs and measured drawings of the remains of the firebox were drawn after the excavation of test units placed on the east and west profile. Additionally, a sample of mortar was taken for comparative analysis.

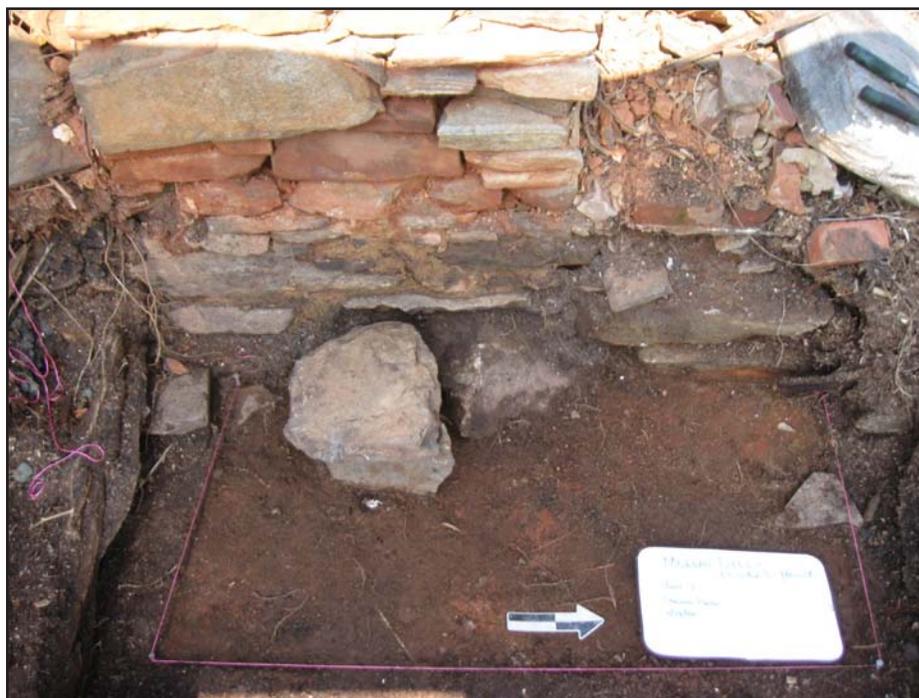
The clearing the house fall debris from Unit 1 revealed dry-stacked stone piers abutting the chimney fall's firebox (Figure 7). The soil around the pier and next to the chimney did not present evidence of the presence of a builders' trench. When the fill was removed to culturally sterile subsoil, the western profile of the unit revealed a thin stratum of soil underlining the stones of the chimney. Artifact content of the soils around the stacked stone pier and adjacent to the firebox contained a number of objects likely deposited by loss between the floorboards of the house. These artifacts included two 1893 pennies, a child's train toy composed of metal and plastic, a glass marble, a shell button, and various nail fragments. One artifact that was not the result of loss, but rather deposited during the construction of the pier, was a single fragment of historic ceramic plotted in the soil next to the pier. The ceramic had a stippled transfer print decoration, brown in color. This type of ceramic surface treatment began production around 1828 and was popular during the 1870s (Miller et. al 2002). Later patterns of brown stippled transfer printed ceramics were garish

A. Unit 1, Exposed Pier

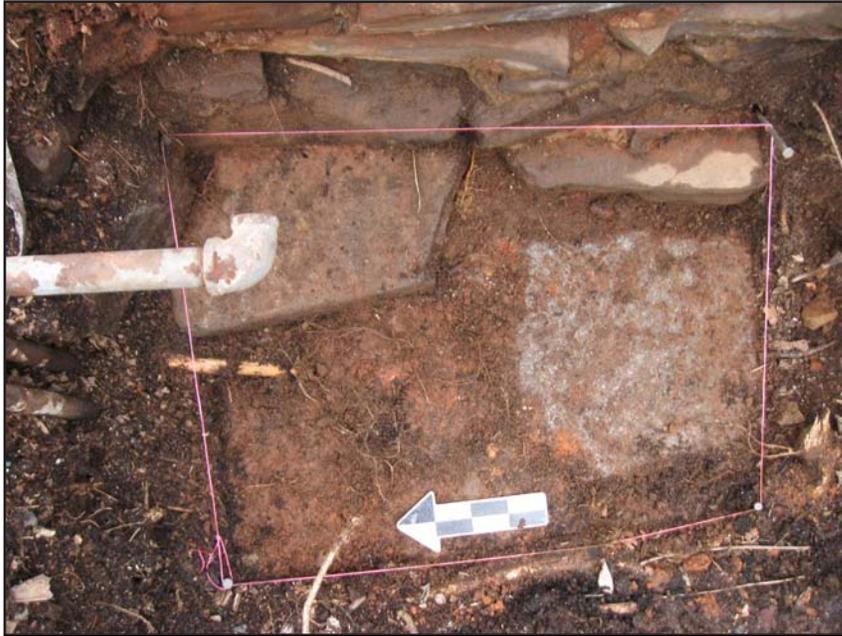
Excavation of the fill of Unit 2 began after the removal of a water heater that was situated against the western side of the firebox. Additionally, an associated water pipe was noted on the northern edge of the unit after the bulk of building debris was removed. Very little soil was exposed in the unit with over half of the unit surface comprised of stones from the hearth and stones supporting the water heater (Figure 8). The hearth stones noted along the eastern edge of Unit 2 were comprised of the weathered schist and gneiss stones found remainder of the chimney fall, but the stones observed under the location of the water heater were congruent with the stone piers bonded in modern concrete located in the northeastern portion of the building. The soils excavated from the unit contained plastic sheet fragments likely associated with the impact of the water pipe's installation. Removal of the stones supporting the water heater revealed the chimney stone stepped out an additional 0.15 meters (0.5 ft.) further than the distance observed prior to excavation. No visible builder's trench was identified upon reaching culturally sterile subsoil. One single ceramic fragment was recovered from fill adjacent to the support stones of the water heater. The single ceramic cataloged from Unit 2 featured a polychromatic decal surface treatment. Decal decoration on ceramics began in the 1890s, and their use persisted well into the twentieth century. It is likely the ceramic recovered from Unit 2 resulted from the installation of the water heater and its support stones.

A. Unit 2, Water Heater Support
Stones
