An Archaeological Assessment of
THE POWER'S HOUSE (Site 9FU561)

Morgan Falls Park, Sandy Springs,

Fulton County, Georgia

August 18, 2009 • Redacted Report
New South Associates Technical Report 1775

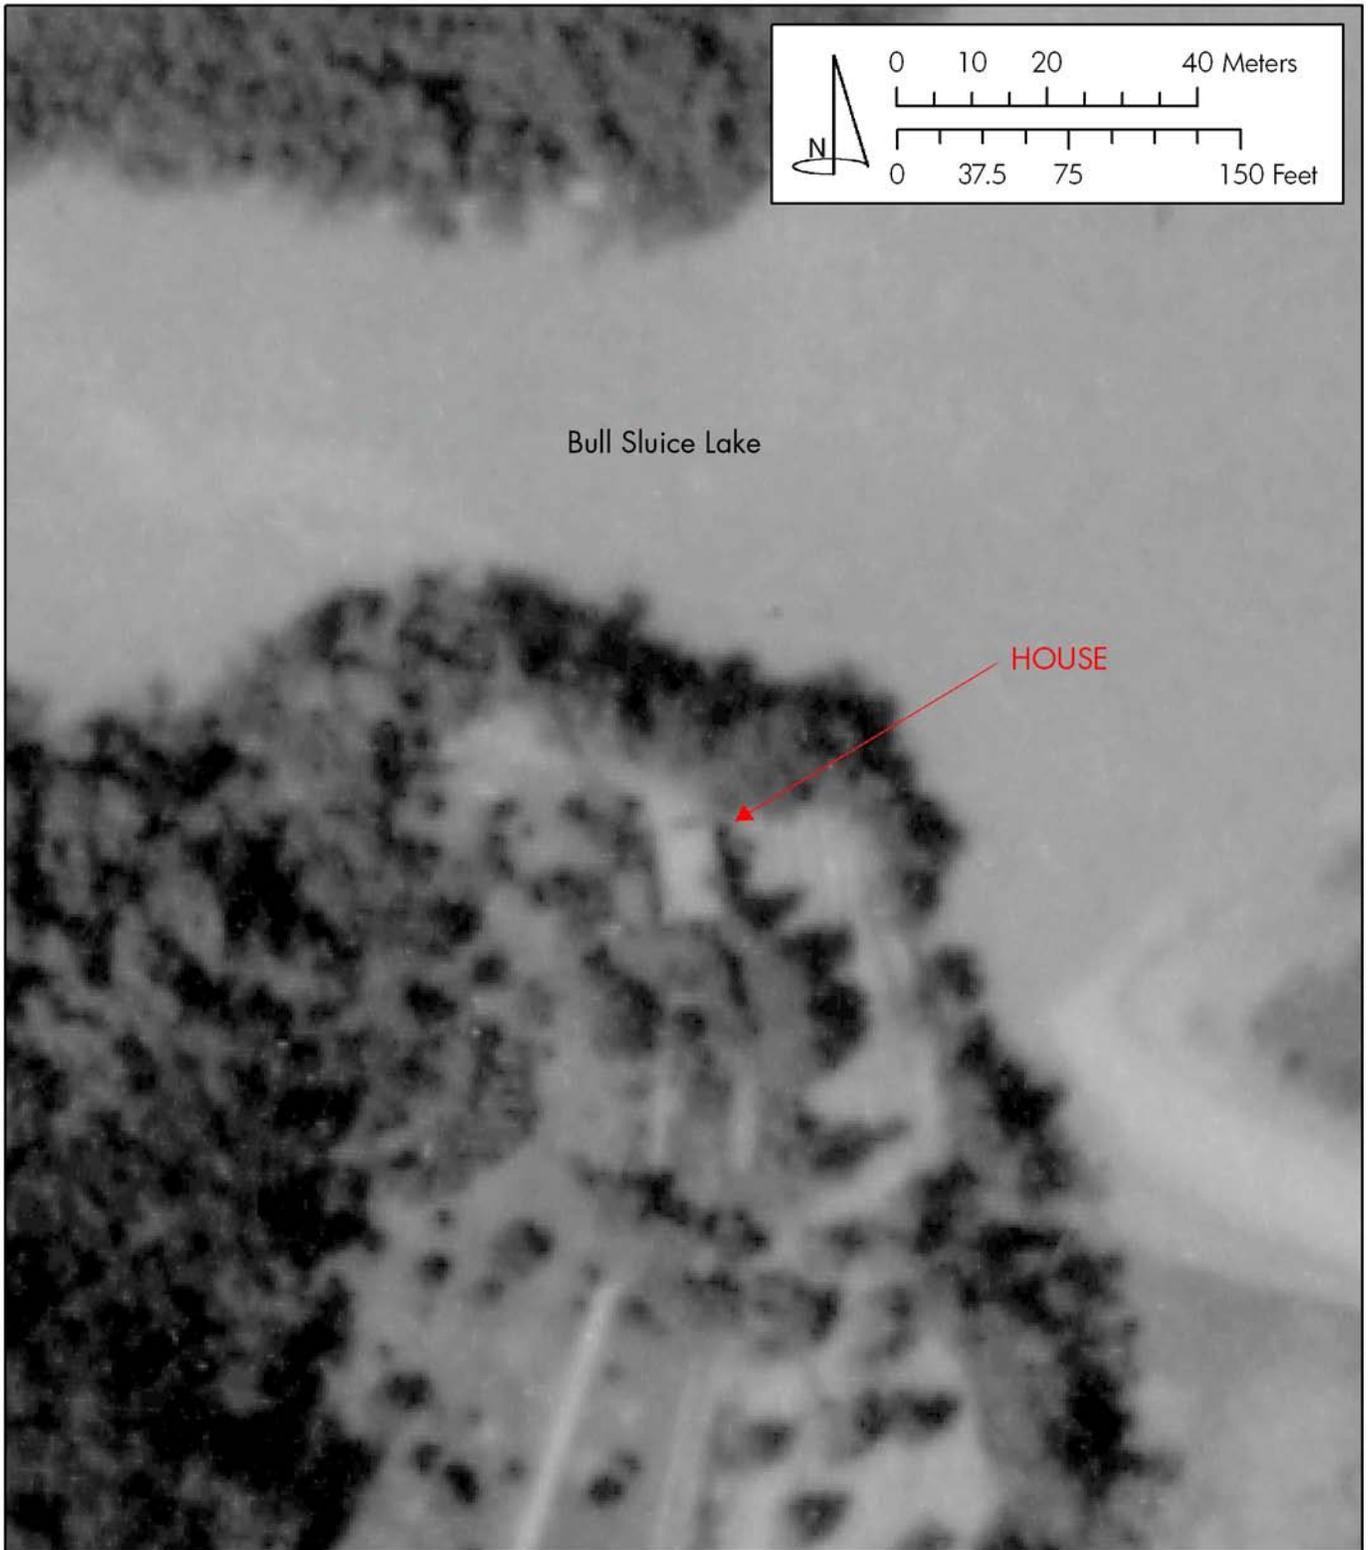
Figure 9.
The House at 9FU561 in 1938

The property probably remained this way until the turn of the century when Forrest Adair took over the land in 1902. Adair's ownership of the property potentially accounts for the house's rectangular footprint observed in aerial photography from 1938 (Figure 9). Adair may have brought modern utilities to the house and expanded the gabled-ell structure to a larger pyramidal cottage or similar house, featuring an enclosed porch. A transformation such as this would require a new roof and potentially new cladding on the exterior. However, foundational and masonry components, like stone piers and chimneys, would likely remain intact. A new roofline would account for the mastic observed on the standing chimney as well as the brick cap in the debris from the chimney fall.
